PHASE I ENVIRONMENTAL SITE ASSESSMENT REPORT

**UNION COUNTY
COUNTY AIRPORT PARCEL
SW STATE ROAD 121
LAKE BUTLER, FLORIDA
ACRES NO. 258035**

PPM PROJECT NO. 20165101-TASK 13

DECEMBER 6, 2023

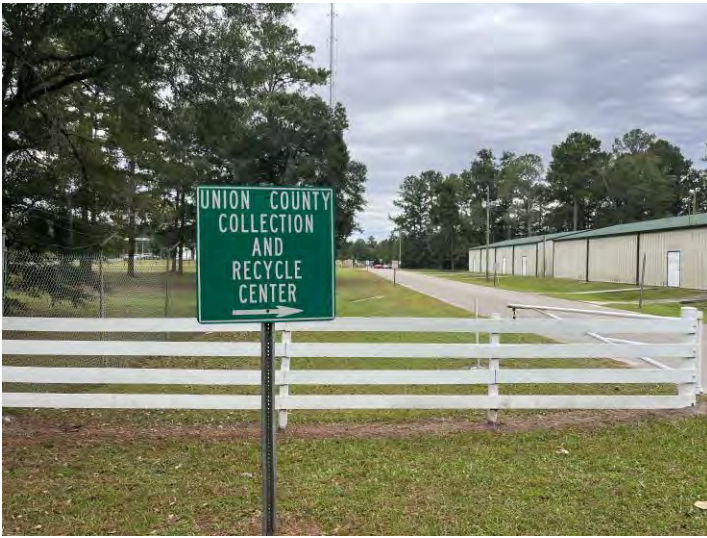
PHOTOGRAPH 1

View of the entrance to the north-central portion of the subject property, facing southeast.

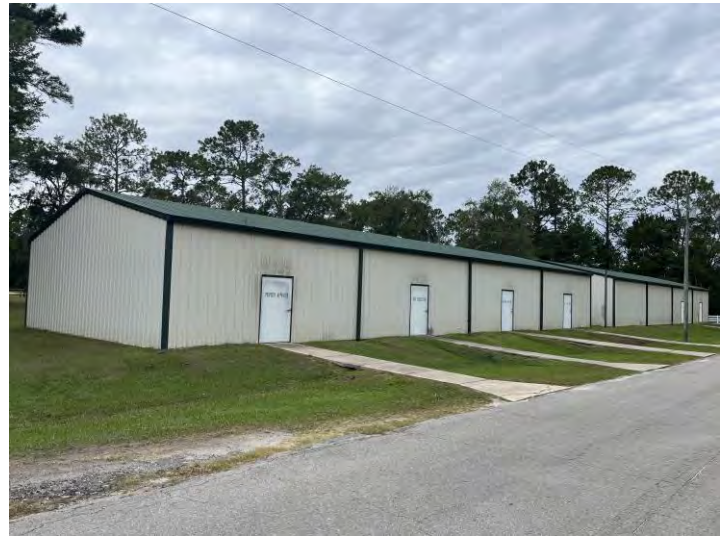
PHOTOGRAPH 2

View of storage structures for Union County on the north-central portion of the subject property, facing west-northwest.

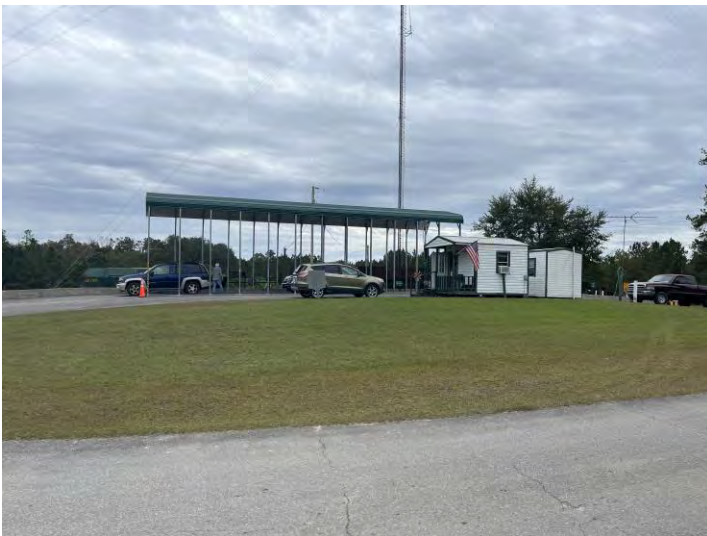
PHOTOGRAPH 3

View of two office sheds and carport at the recycling center on the north-central portion of the subject property, facing southeast.

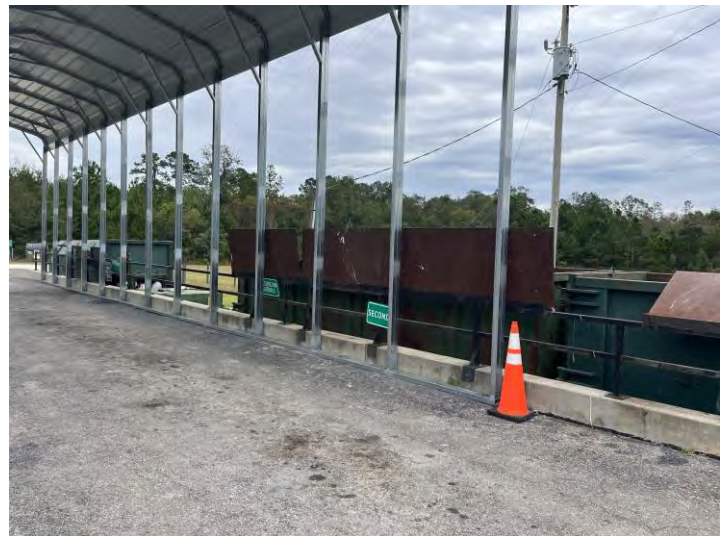
PHOTOGRAPH 4

View of two dumpsters and a hydraulic trash compactor at the recycling center on the north-central portion of the subject property, facing east.

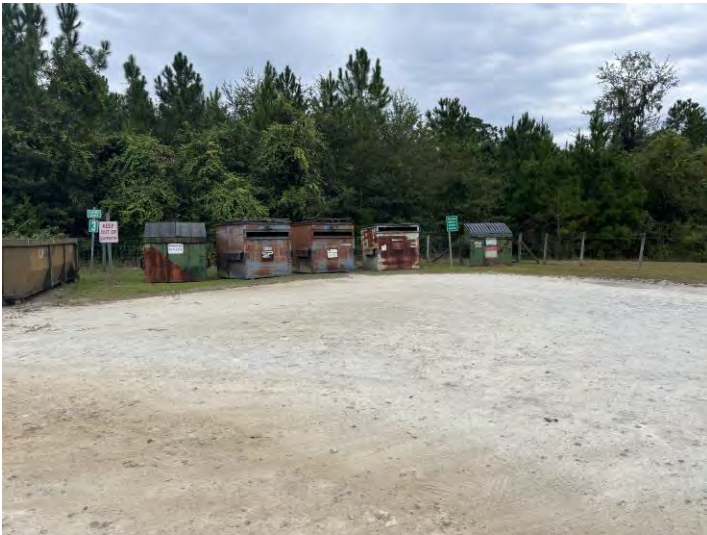
PHOTOGRAPH 5

View of dumpsters at the recycling center on the north-central portion of the subject property, facing northeast.

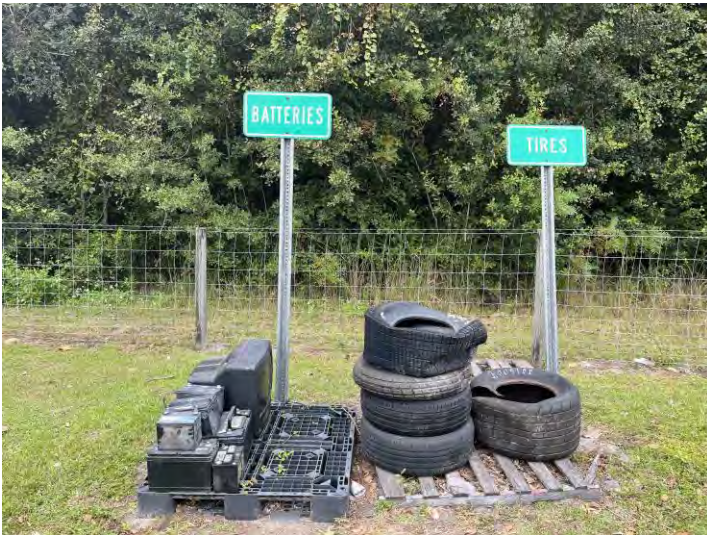
PHOTOGRAPH 7

View of batteries and tires at the recycling center on the north-central portion of the subject property, facing northeast.

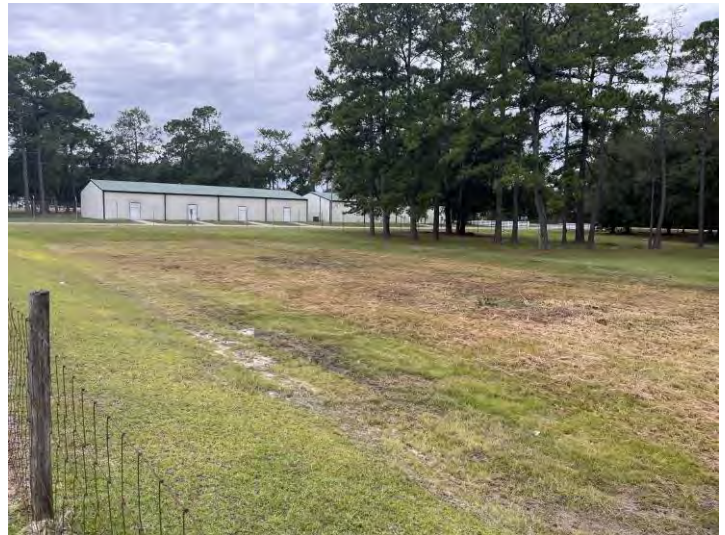
PHOTOGRAPH 8

View of a stormwater drainage detention basin at the recycling center on the north-central portion of the subject property, facing west-southwest.

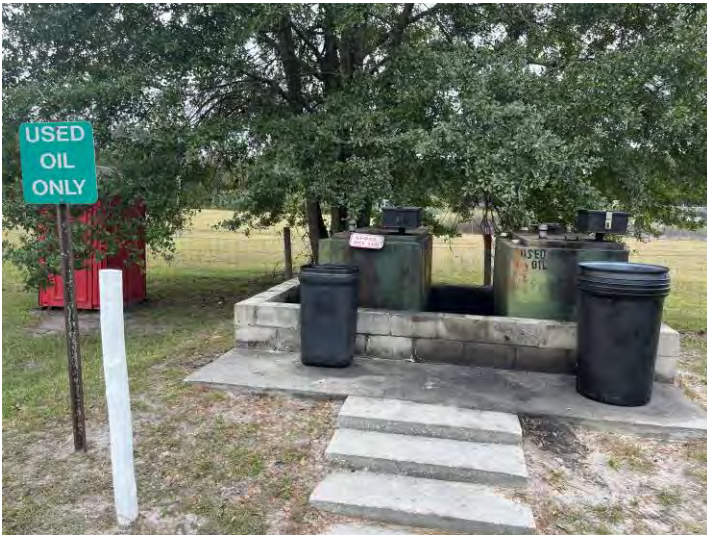
PHOTOGRAPH 9

<p>Storage Tanks: Two used oil ASTs with an estimated capacity of 375 and 450 gallons were observed at the recycling area on the north-central portion of the subject property (Photographs 9 and 10). The tanks are located within a 16-inch high concrete block containment. Motor oil staining was observed around the fill ports on top of the ASTs, on the inside and outside of the concrete containment wall, on the concrete floor inside the containment, and on bare ground outside of the containment. This AST containment area appears to have been present since at least 2004. PPM observed a drain connected to a drain pipe coming out</p>

View of two used oil ASTs at the recycling center on the north-central portion of the subject property, facing southeast.

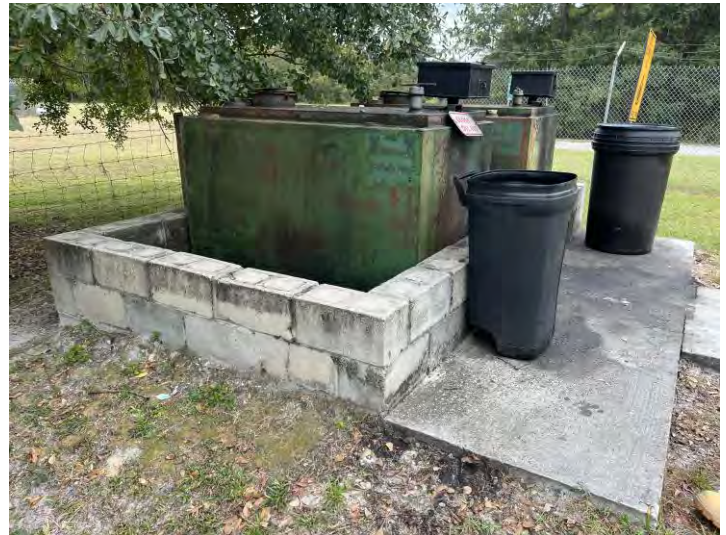
PHOTOGRAPH 10

View of two used oil ASTs at the recycling center on the north-central portion of the subject property, facing south.

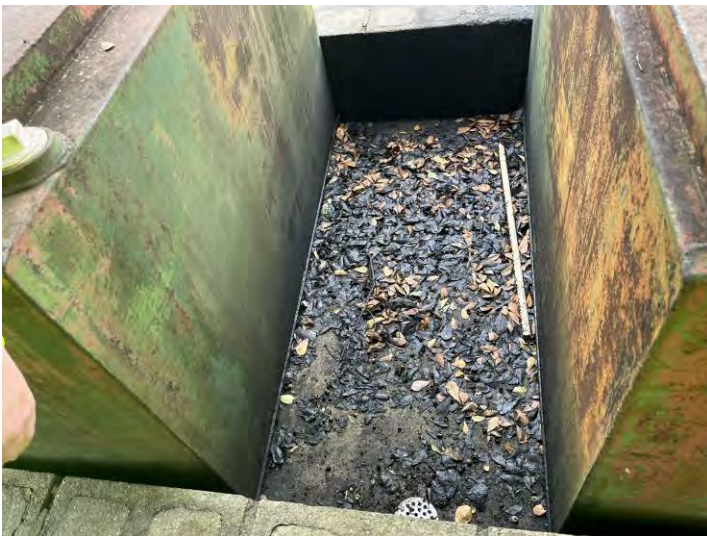
PHOTOGRAPH 11

View of oil at the bottom of the containment for the used oil ASTs at the recycling center on the north-central portion of the subject property.

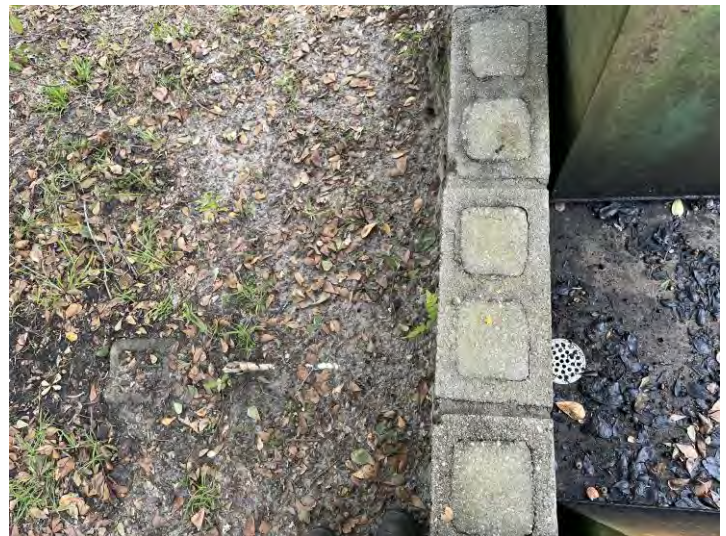
PHOTOGRAPH 12

<p>of the containment that would keep the containment from filling up with rain water. Motor oil staining appears to have discharged onto the bare ground at the end of the drain pipe.</p> <p>A horizontal propane tank was observed outside of the communications tower compound in the center of the subject property (Photograph 19). A vertical propane tank was observed outside of the concessions structure on the west portion of the subject property (Photograph 23). Two vertical propane tanks were observed outside of the horse riding viewing structure on the west portion of the subject property (Photograph 30). Given that the tanks contained propane, they are not further discussed.</p>
<p>Strong Odors & Sources: None observed</p>
<p>Standing Surface Water, Pools, or Sumps Containing Liquids: None observed</p>
<p>Drums, Totes, & Intermediate Bulk Containers: Several 55-gallon plastic drums were observed at the horse riding area on the west portion of the subject property. These drums were either used for trash or as boundaries markers for horse riding activities.</p> <p>One 55-gallon plastic drum that was partially full of cooking grease was observed outside of the concessions structure on the west portion of the subject property (Photograph 23). One 55-gallon metal drum that appeared to be full of rainwater was observed in the area of the barn on the west portion (Photograph 34). No stressed vegetation, staining, or evidence of release was observed in the vicinity of these containers.</p>

View of staining at the drain at the bottom of the containment for the used oil ASTs at the recycling center on the north-central portion of the subject property.

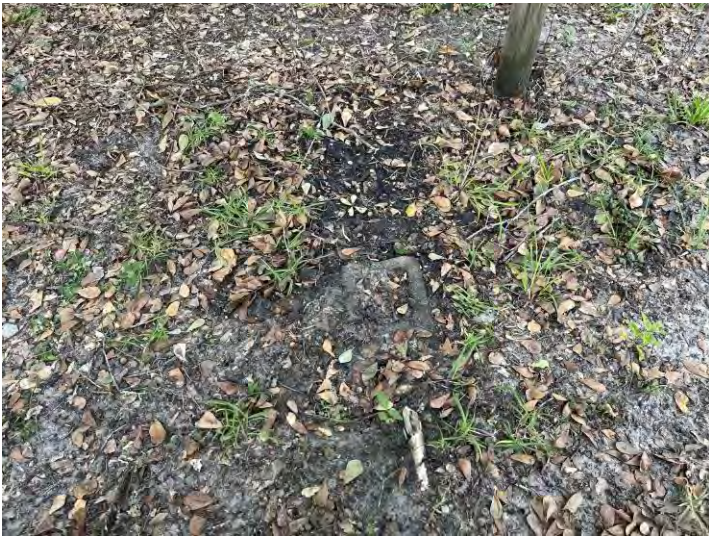
PHOTOGRAPH 13

View of staining at the discharge point for the drain inside the containment for the used oil ASTs at the recycling center on the north-central portion of the subject property.

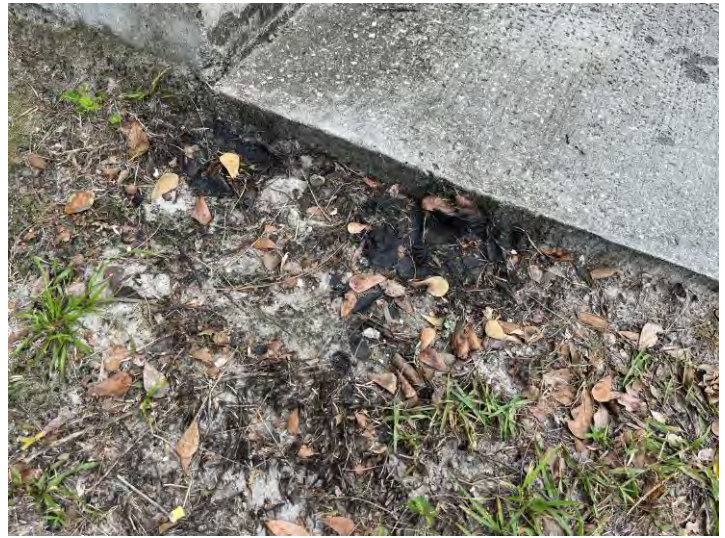
PHOTOGRAPH 14

View of staining outside of the containment for the used oil ASTs at the recycling center on the north-central portion of the subject property.

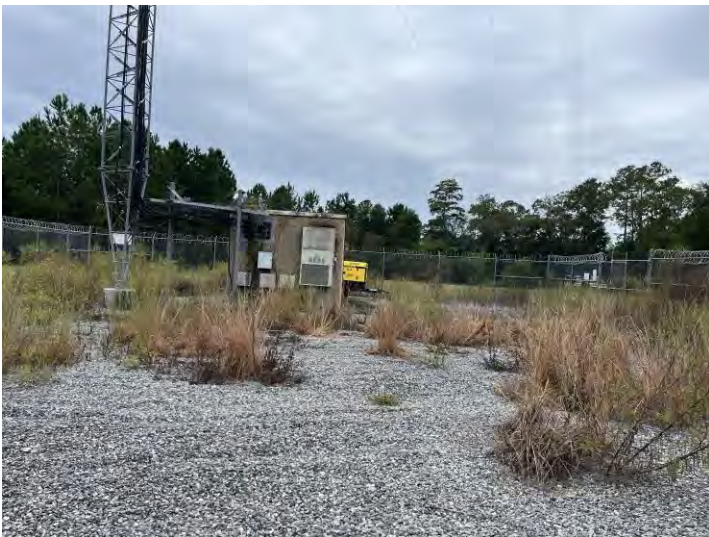
PHOTOGRAPH 15

View of a communications tower compound at the north-central portion of the subject property, facing southwest.

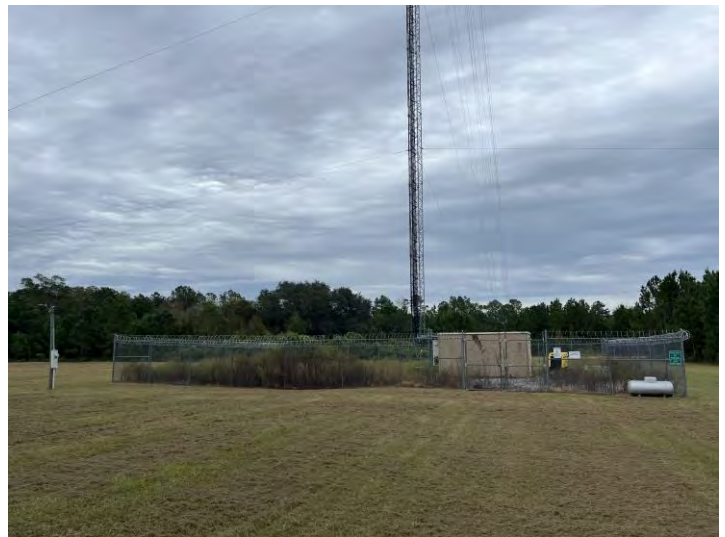
PHOTOGRAPH 16

View of a communications tower compound at the north-central portion of the subject property, facing southeast.

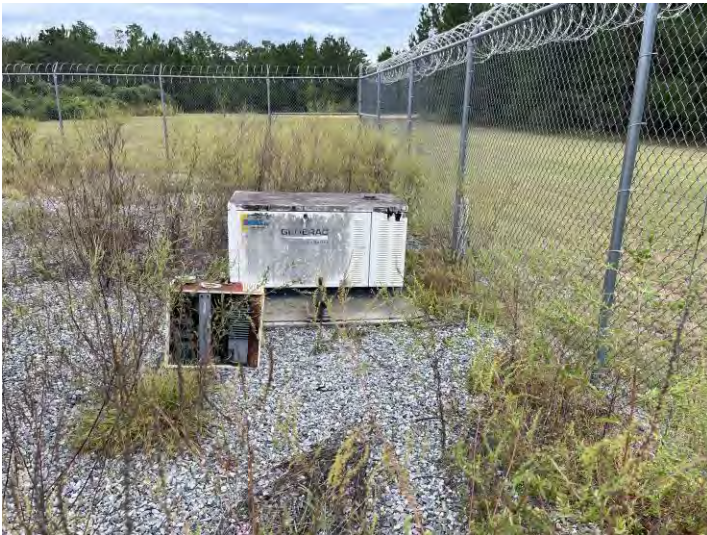
PHOTOGRAPH 17

View of a propane-powered generator within the communications tower compound on the north-central portion of the subject property, facing southeast.

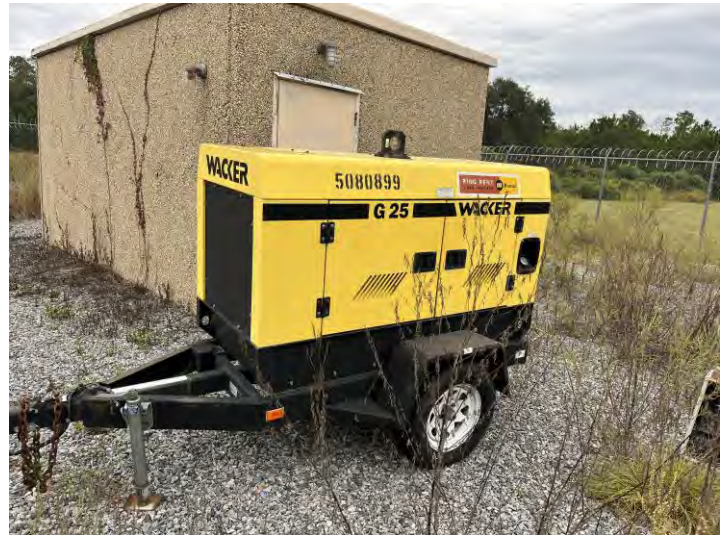
PHOTOGRAPH 18

View of a diesel-powered generator within the communications tower compound on the north-central portion of the subject property, facing north.

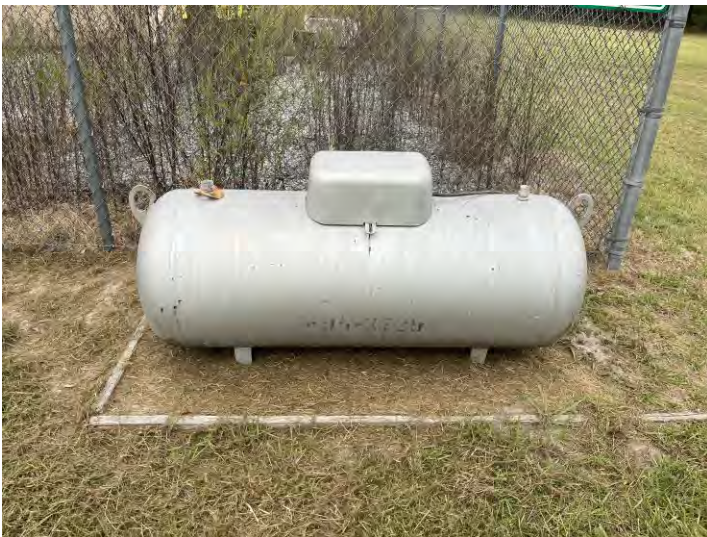
PHOTOGRAPH 19

View of a propane tank outside of the communications tower compound on the north-central portion of the subject property, facing southeast.

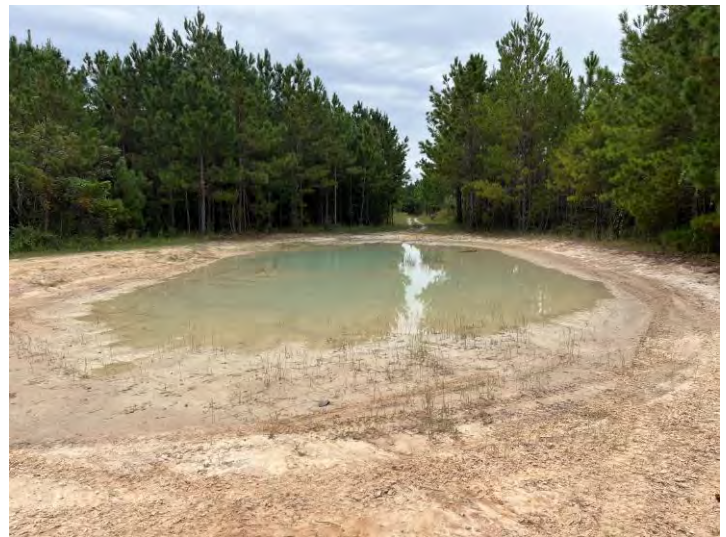
PHOTOGRAPH 20

View of a pond on the east-central portion of the subject property, facing south.

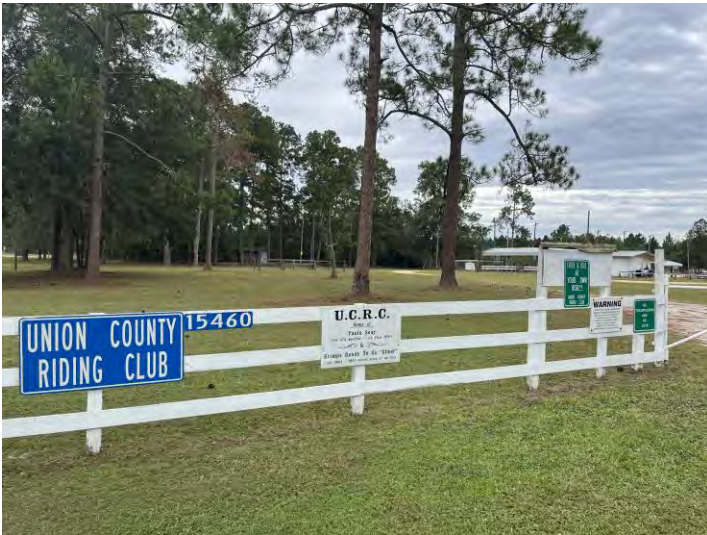
PHOTOGRAPH 21

View of the Union County Riding Club on the west portion of the subject property, facing south-southeast.

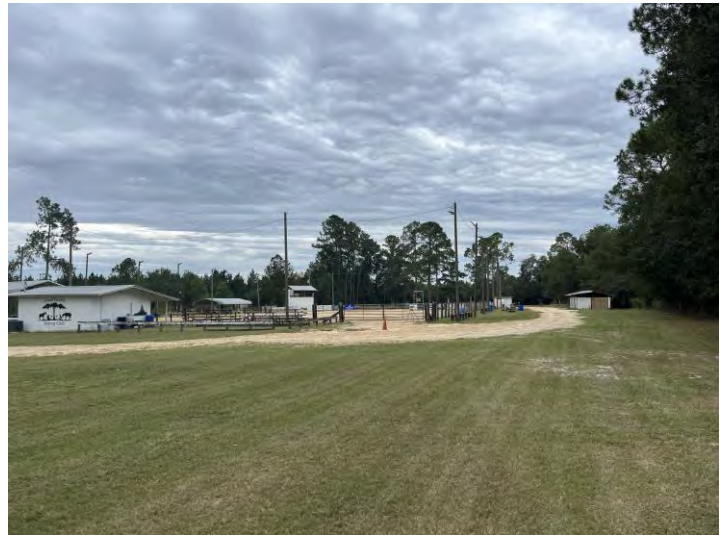
PHOTOGRAPH 22

View of the Union County Riding Club on the west portion of the subject property, facing south-southeast.

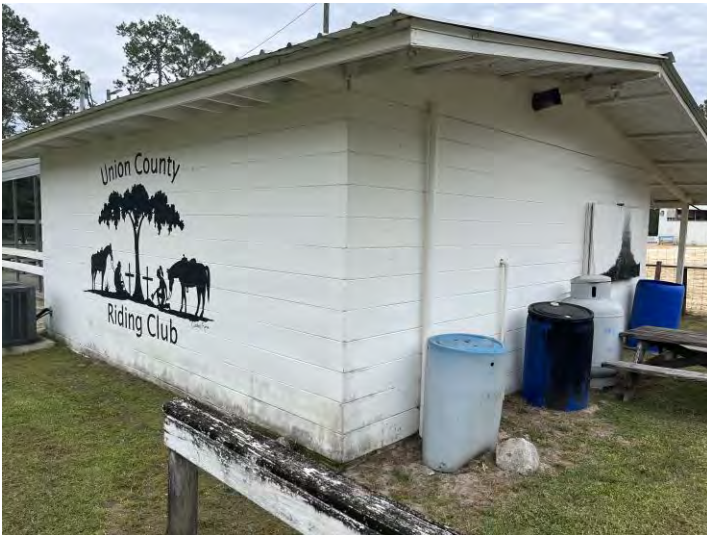
PHOTOGRAPH 23

View of the concession stand at the Union County Riding Club on the west portion of the subject property, facing southeast.

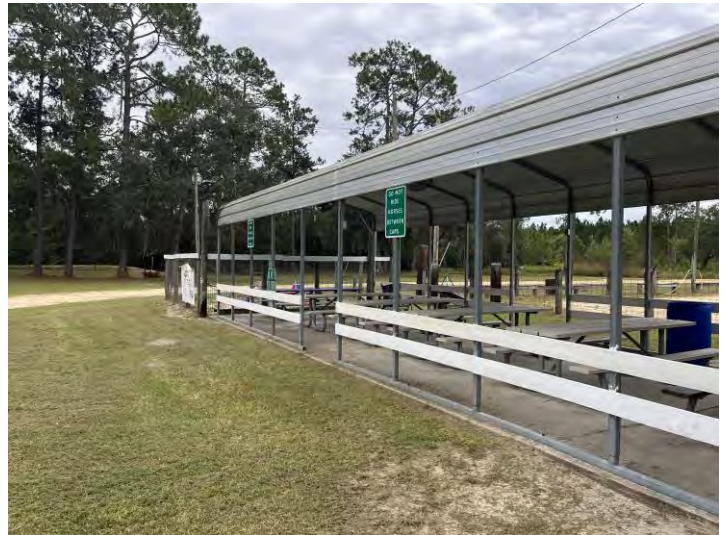
PHOTOGRAPH 24

View of a picnic area at the Union County Riding Club on the west portion of the subject property, facing southeast.

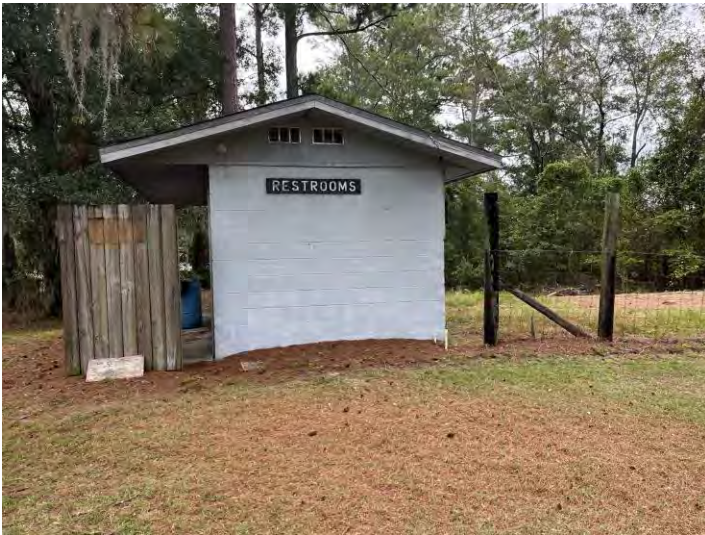
PHOTOGRAPH 25

View of a restroom structure at the Union County Riding Club on the west portion of the subject property, facing northwest.

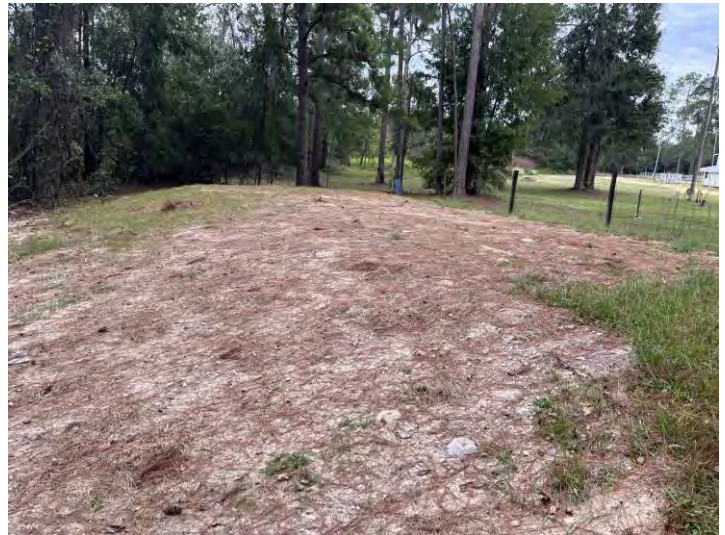
PHOTOGRAPH 26

View of a septic system area at the Union County Riding Club on the west portion of the subject property, facing south.

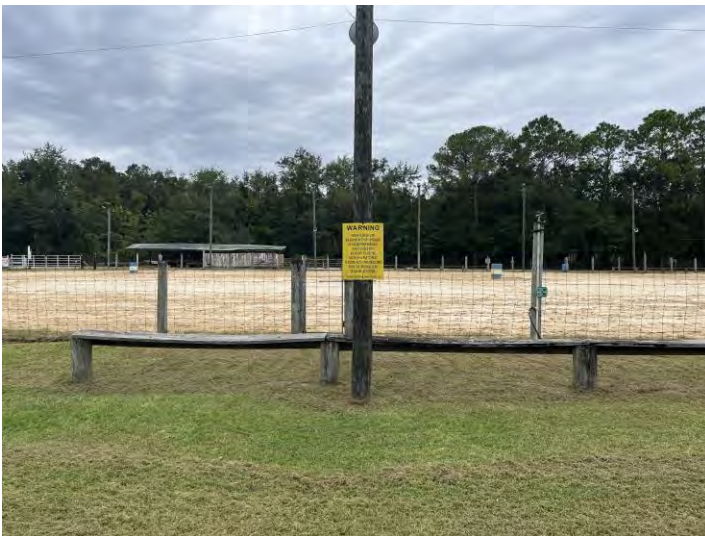
PHOTOGRAPH 27

View of the horse riding area at the Union County Riding Club on the west portion of the subject property, facing east.

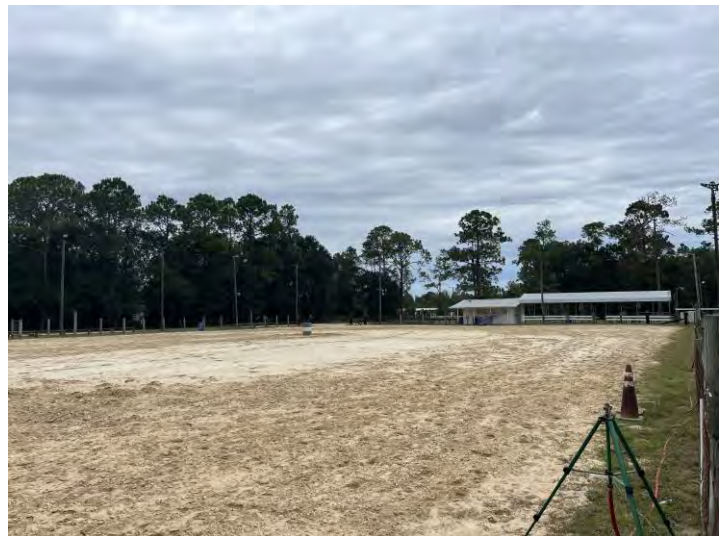
PHOTOGRAPH 28

View of the horse riding area at the Union County Riding Club on the west portion of the subject property, facing north-northwest.

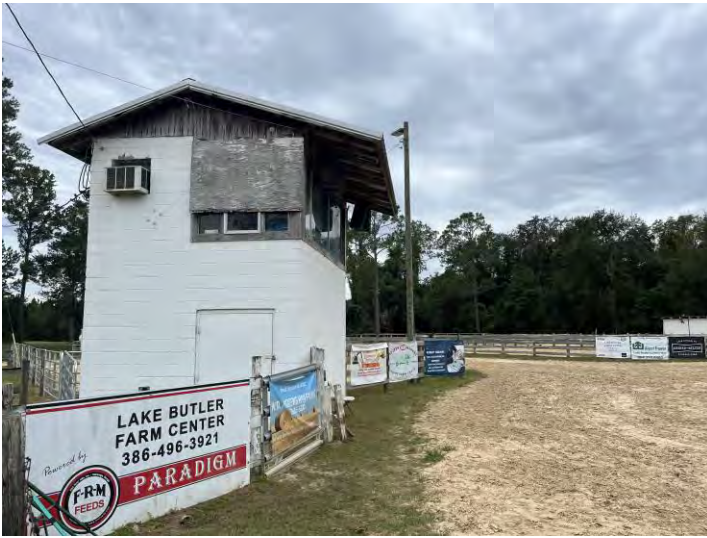
PHOTOGRAPH 29

View of the viewing structure for the horse riding area at the Union County Riding Club on the west portion of the subject property, facing southwest.

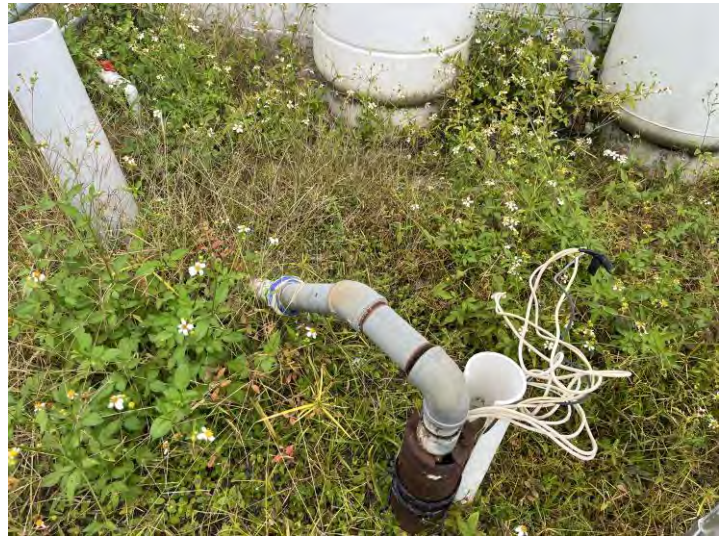
PHOTOGRAPH 30

View of a water well next to the viewing structure for the horse riding area at the Union County Riding Club on the west portion of the subject property.

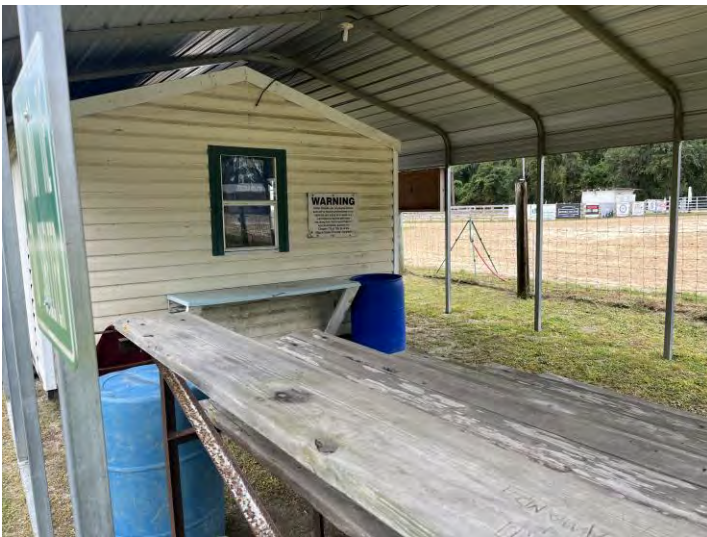
PHOTOGRAPH 31

View of an office shed at the Union County Riding Club on the west portion of the subject property, facing southwest.

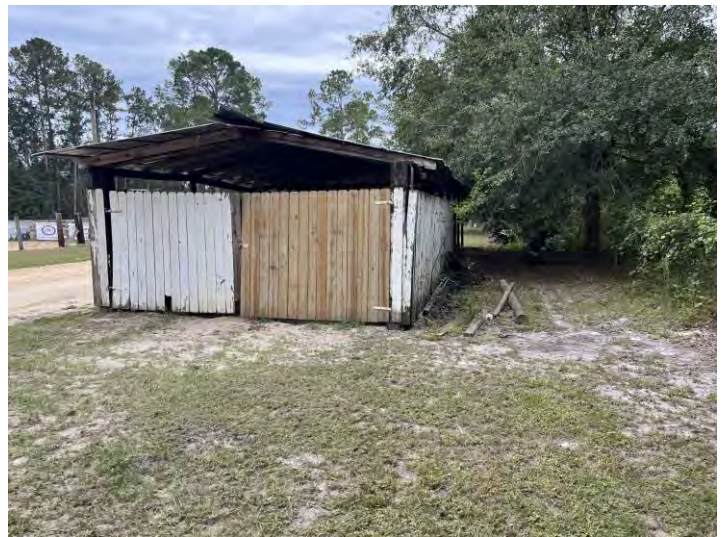
PHOTOGRAPH 32

View of a barn at the Union County Riding Club on the west portion of the subject property, facing southeast.

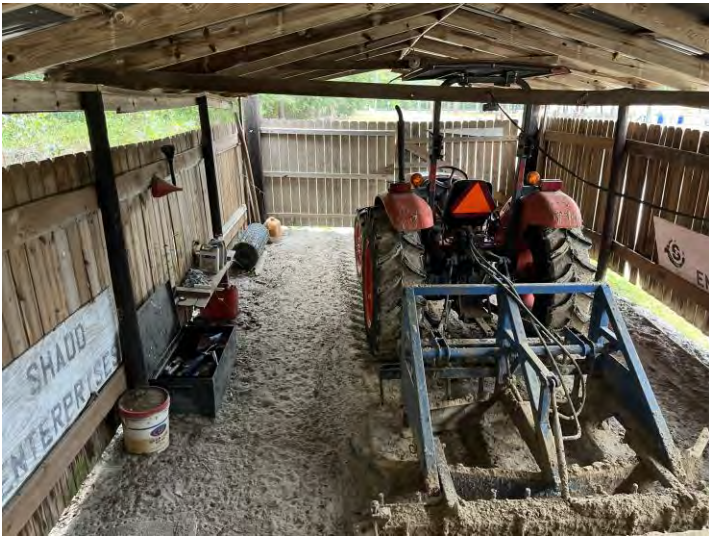
PHOTOGRAPH 33

View of the inside of a barn at the Union County Riding Club on the west portion of the subject property, facing north.

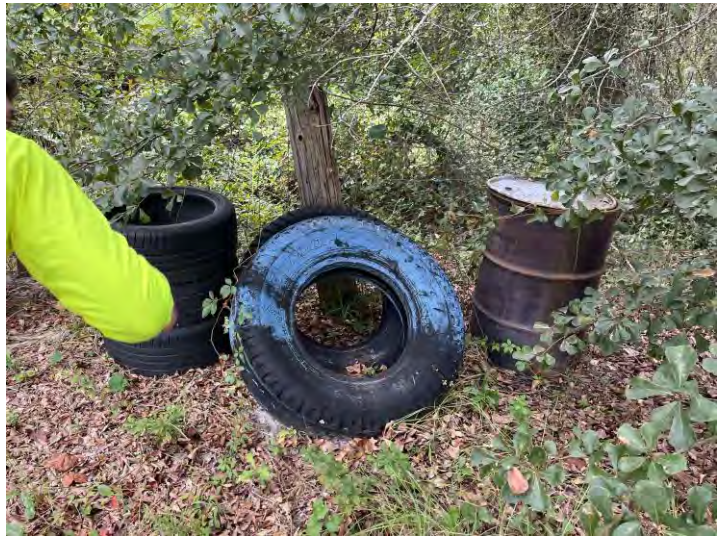
PHOTOGRAPH 34

View of tires and a drum containing rainwater next to a barn at the Union County Riding Club on the west portion of the subject property, facing southwest.

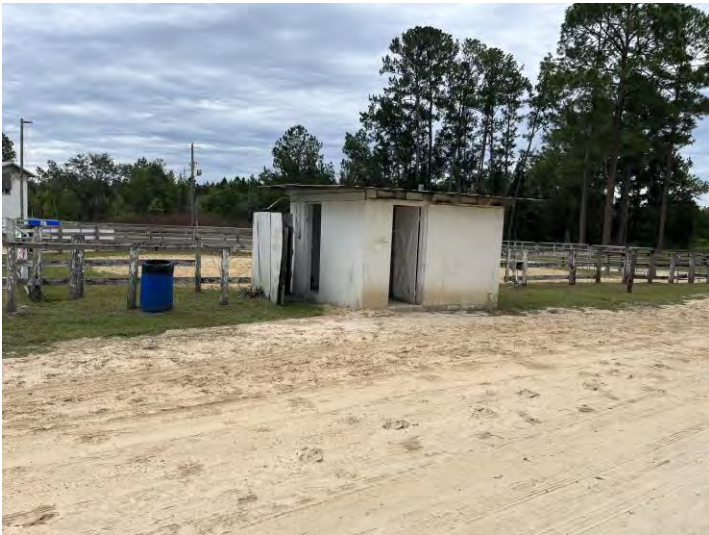
PHOTOGRAPH 35

View of a restroom structure at the Union County Riding Club on the west portion of the subject property, facing southeast.

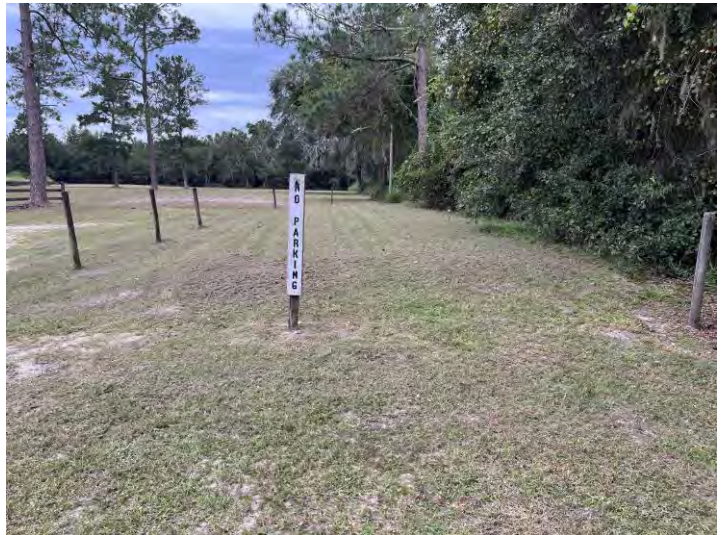
PHOTOGRAPH 36

View of septic system area at the Union County Riding Club on the west portion of the subject property, facing south.

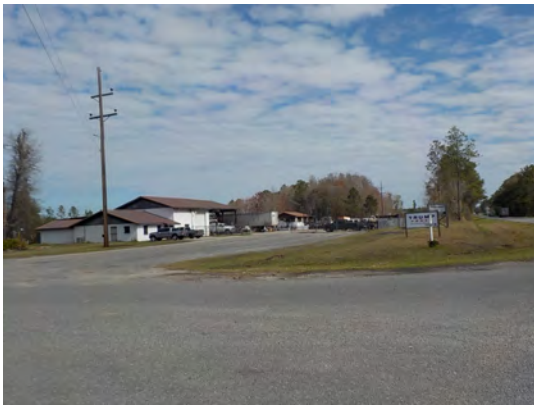
AST site.

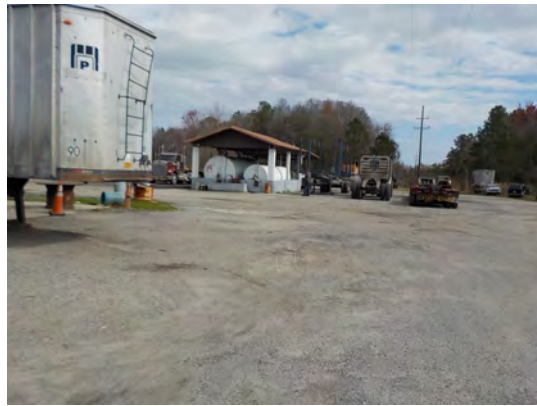
Tank 1.

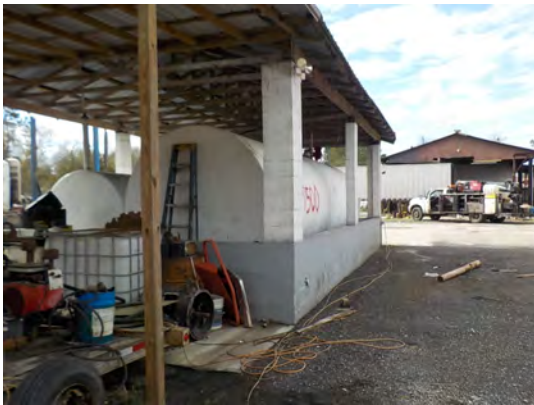
Tank 1.

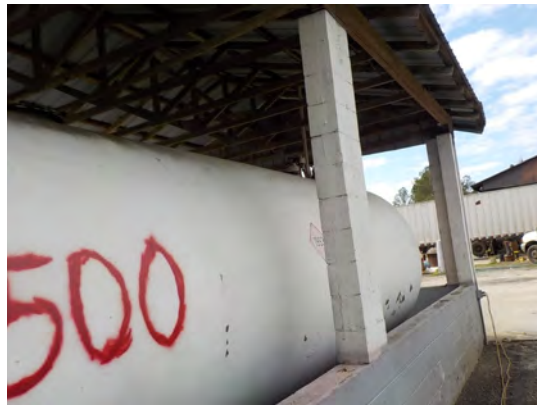
Tank 1.

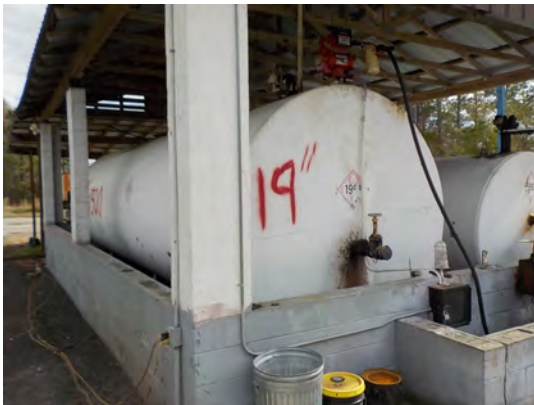
Product dispenser station.

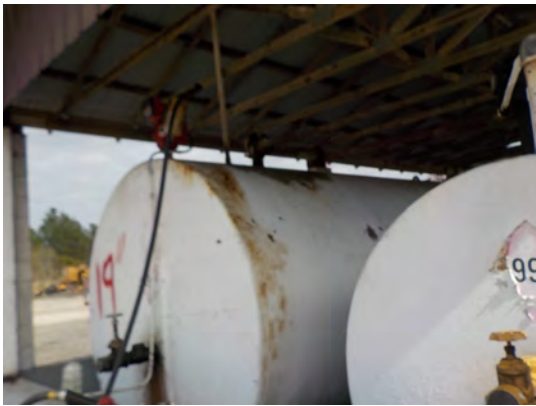
Added Date 03/02/2021

Tank 1.

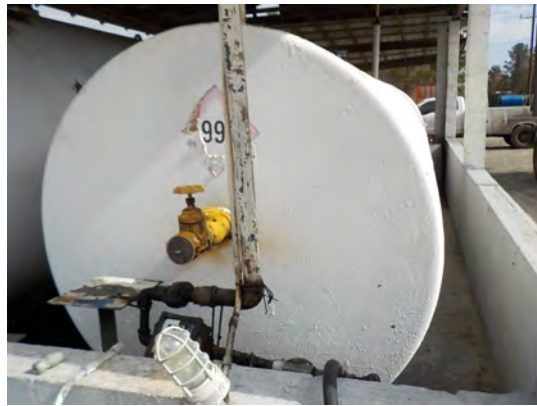
Added Date 03/02/2021

Tank 2.

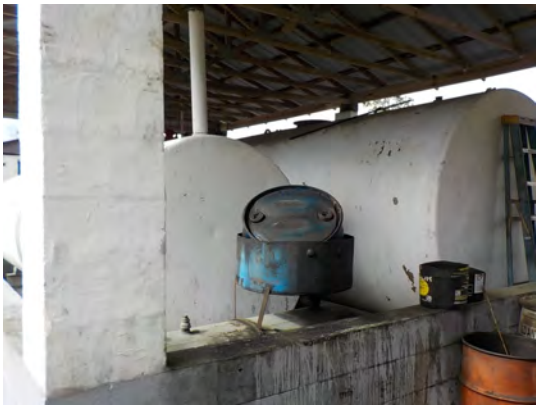
Added Date 03/02/2021

Tank 2.

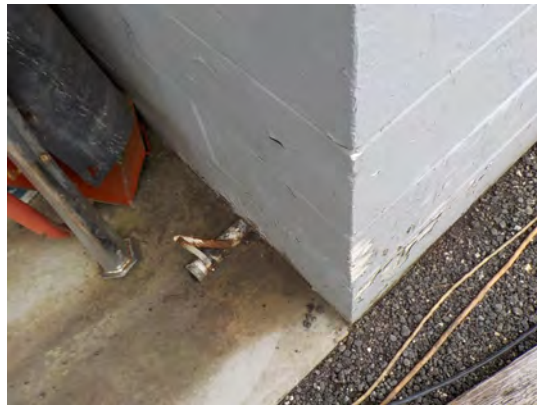
Added Date 03/02/2021

Containment drain valve.

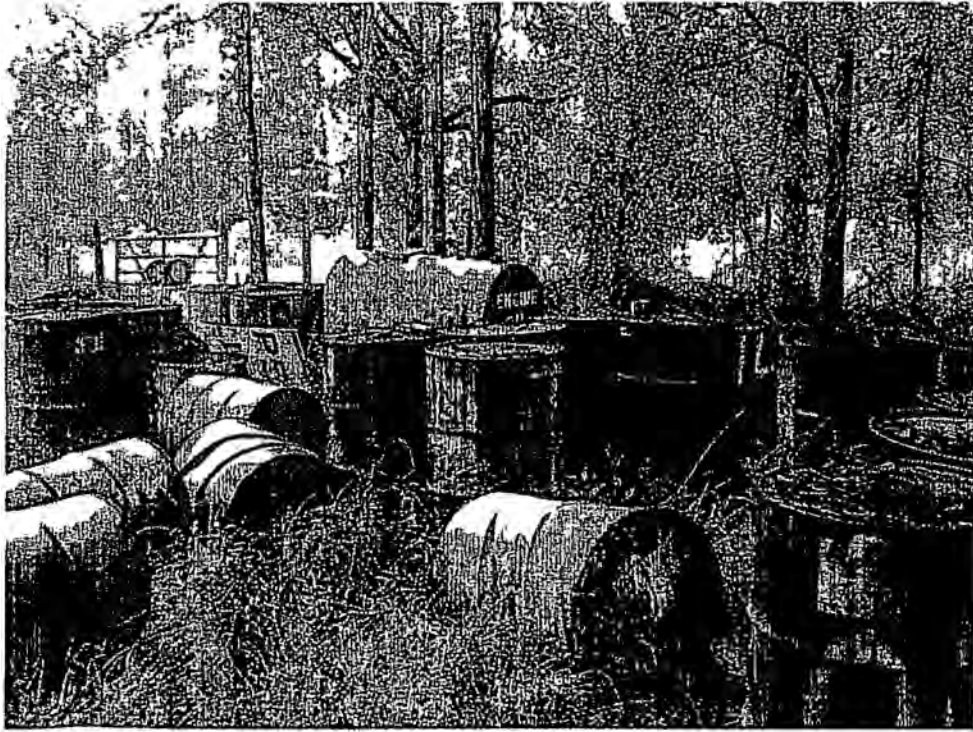
Photo 1

Hendricks Turf, Inc. is an agricultural sod farm facility, generating used oil, used oil filters and used batteries from farm equipment maintenance operations. The facility is a non-handler of hazardous waste. The facility had recently relocated operations from another farm site and moved several empty used oil 55-gallon containers and one 300-gallon aboveground used oil storage tank (AGT) to this site. According to Mr. Donny Crawford, the site manager, some of the drums had been left open allowing rainwater to accumulate in the drums and some of this oily wastewater was spilt on the ground. (Photo 1) At the time of the inspection petroleum stained soil was observed around an area where used oil storage containers had been being stored. **Failure to immediately contain and clean up a release of used oil is a violation of 40 CFR 279.22(d).** Also at the time of the inspection it was observed that used oil was being collected in a 5-gallon unlabeled and open container. (Photo 2) **Failure to labeled storage containers for used oil with the words "Used Oil" is in violation of 40 CFR 279.22.**

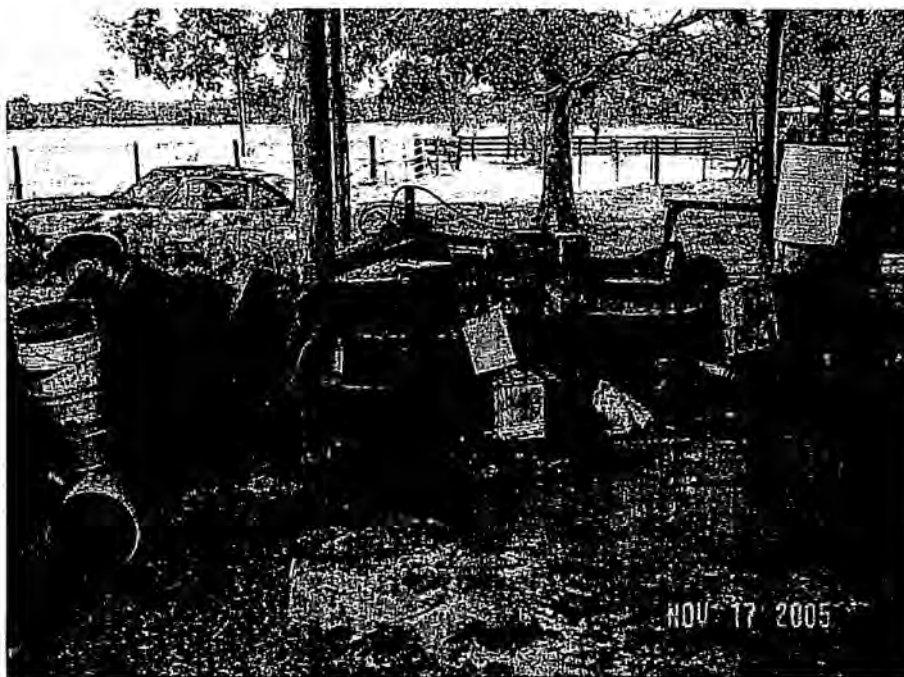
Photo 4

At the time of the inspection several lead acid batteries were observed being stored under a roofed shed on the concrete floor. (Photo 4) According to Mr. Bryan Hendricks the batteries were from his farm operations and not Hendricks Turf. The Department recommends that facility personnel store all spent lead acid batteries in a sheltered area and on an acid impermeable floor to prevent an accidental release of lead contaminated battery acid to the environment. Any lead acid battery with cracked or broken casings should be placed in a suitable container that will prevent the release of lead contaminated battery acid. Spent lead acid batteries should be managed per 40 CFR 266.80, or as universal waste managed per 40 CFR 261.9 and 40 CFR 273.
